SignalTight[™] Trial #314

700 Subscriber Node w/ 2 Return Path TX's and 1 Forward Reciever.

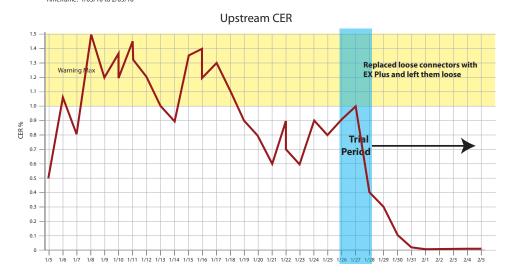
Topology: Logical Upstream Channel 61007 Timeframe: 1/05/10 to 2/05/10

The following diagrams prove the performance enhancements with the use of the PPC EXPLUS connectors. The improvements noted are a result of significantly reduces reflections and impulse noise previously caused by intermittent ground contact.
